Asbestos-Containing Materials
Abatement Specification
CFSH – Building 15 Demolition
7901 Farrow Road
Columbia, South Carolina
S&ME Project No. 210385

January 19, 2021

Reference: **Asbestos-Containing Materials Abatement Specification**
CFSH – Building 15
7901 Farrow Road
Columbia, South Carolina
S&ME Project No. 210385

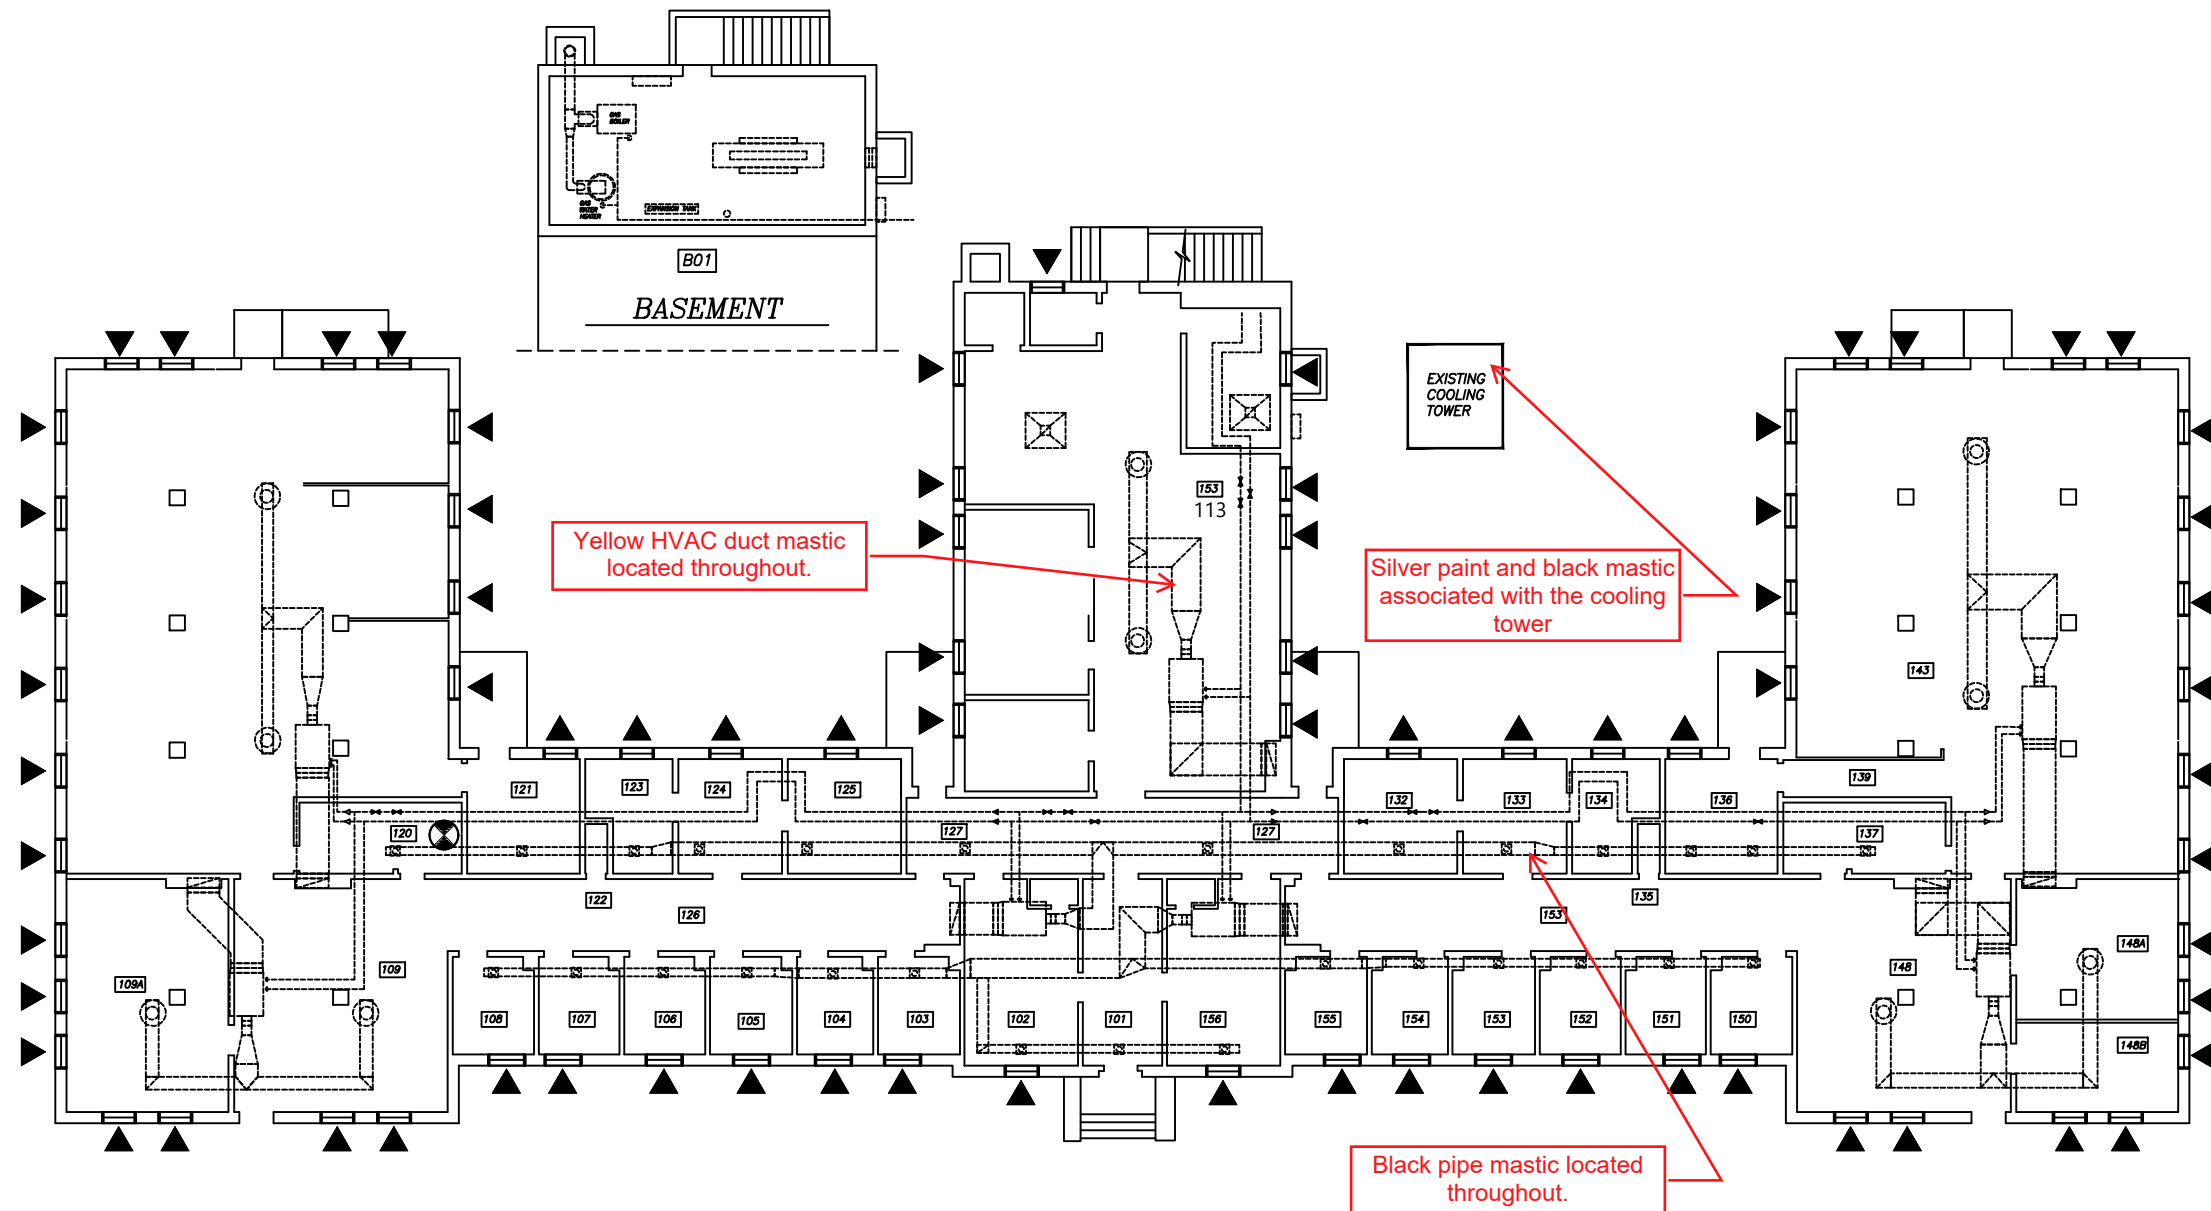
FIGURE NO.

- GRAY SINK COATING (4% CHRYSOTILE)
- ▲ WINDOW GLAZING ON ALL EXTERIOR WINDOWS (2% CHRYSOTILE)
- SILVER PAINT ASSOCIATED WITH COOLING TOWER (3% CHRYSOTILE)
- BLACK MASTIC ASSOCIATED WITH COOLING TOWER (4% CHRYSOTILE)
- HARD JOINT INSULATION ASSOCIATED WITH COOLING TOWER (2% CHRYSOTILE)
- YELLOW HVAC DUCT MASTIC THROUGHOUT (2% CHRYSOTILE)
- BLACK PIPE MASTIC THROUGHOUT (2% CHRYSOTILE)
- ASPHALT SHINGLES (2% CHRYSOTILE)

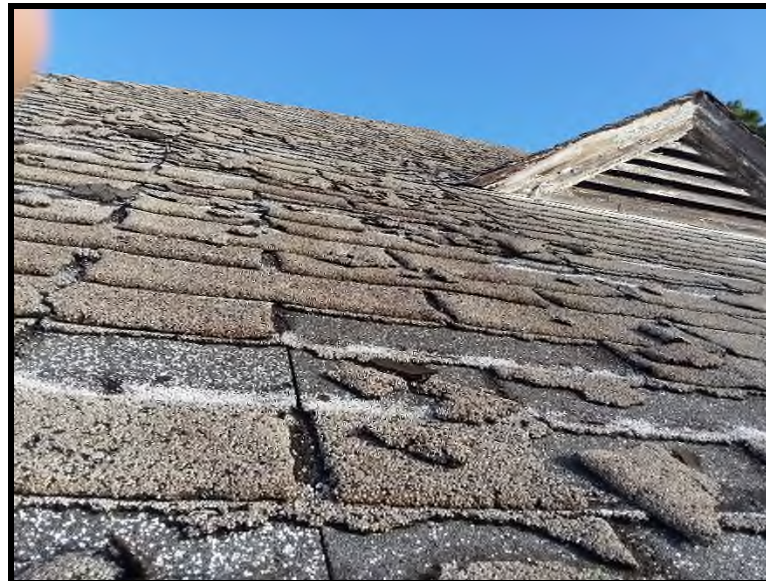
2 The asphalt shingles tested positive for asbestos (2% chrysotile).

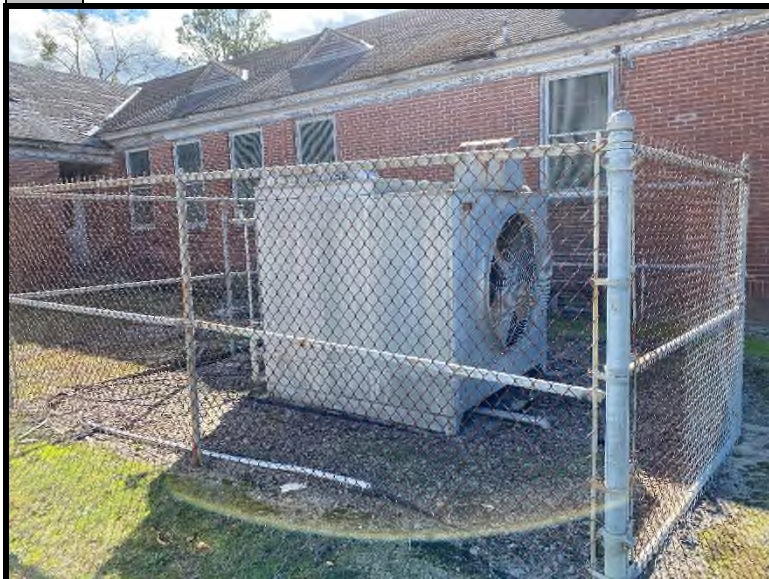
3 The silver paint located on the cooling tower tested positive for asbestos (3% chrysotile).

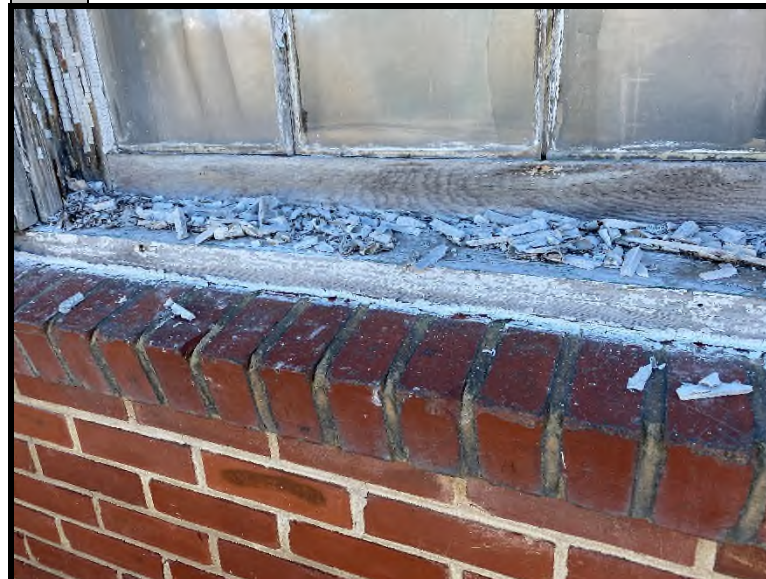
4 The exterior window glazing tested positive for asbestos (2% chrysotile).

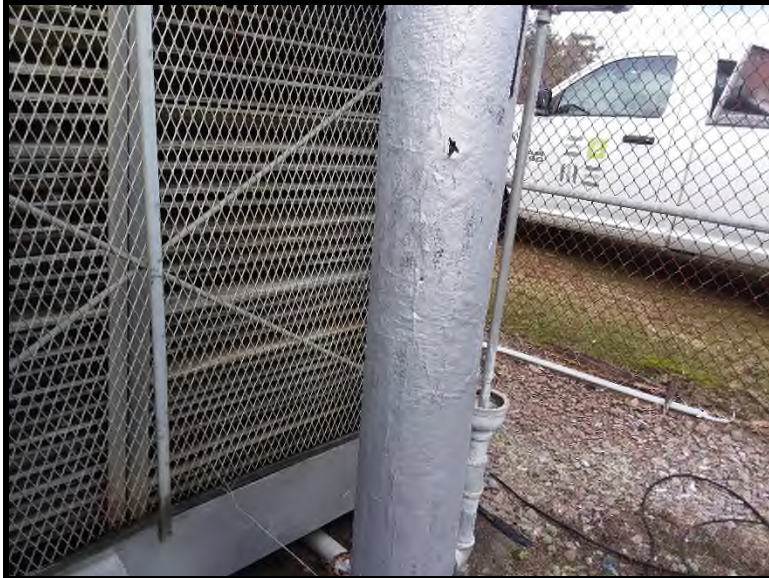
5 The pipe wrap on the sulfur rock insulation tested positive for asbestos (6% chrysotile).

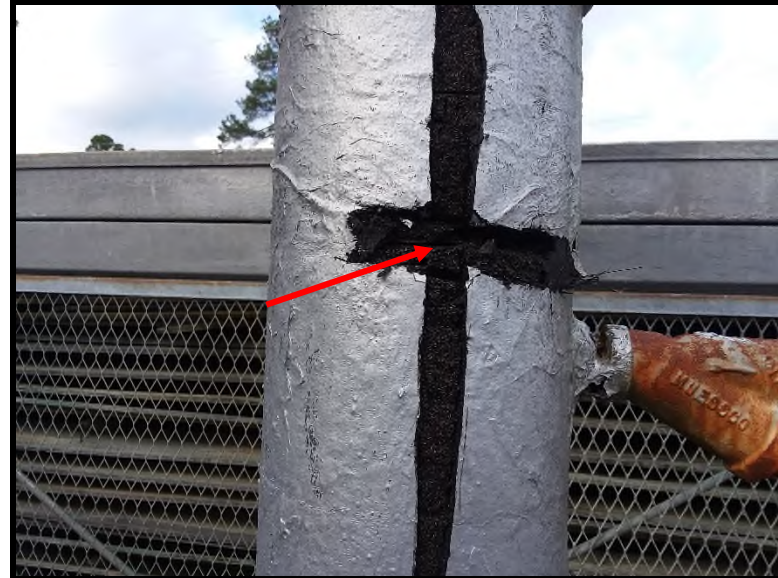
6 The black mastic located between the joints of the sulfur rock insulation tested positive for asbestos (4% chrysotile).

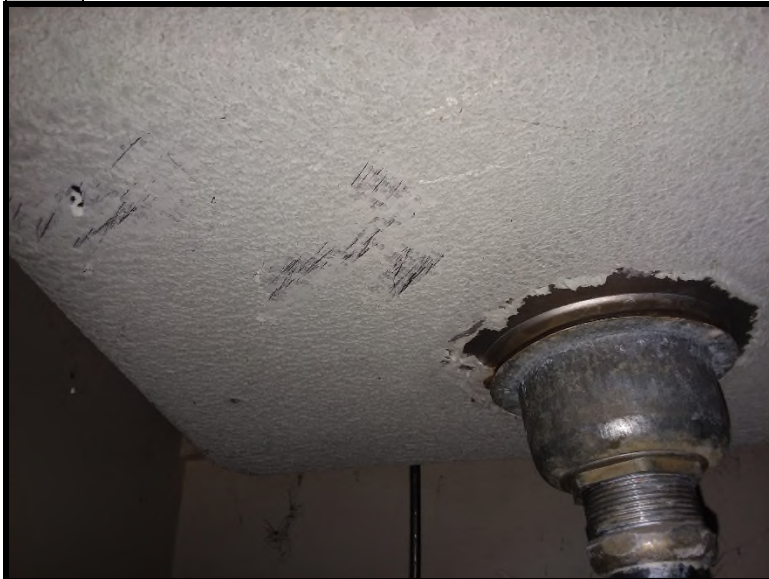
7 The gray sink coating located on the south side of the building tested positive for asbestos (4% chrysotile).

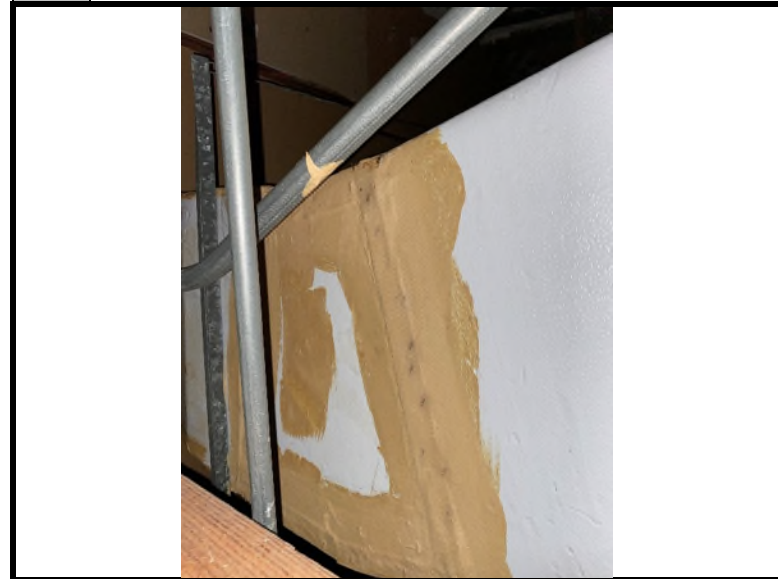
8 The yellow duct mastic located on the HVAC ducts tested positive for asbestos (5% chrysotile).

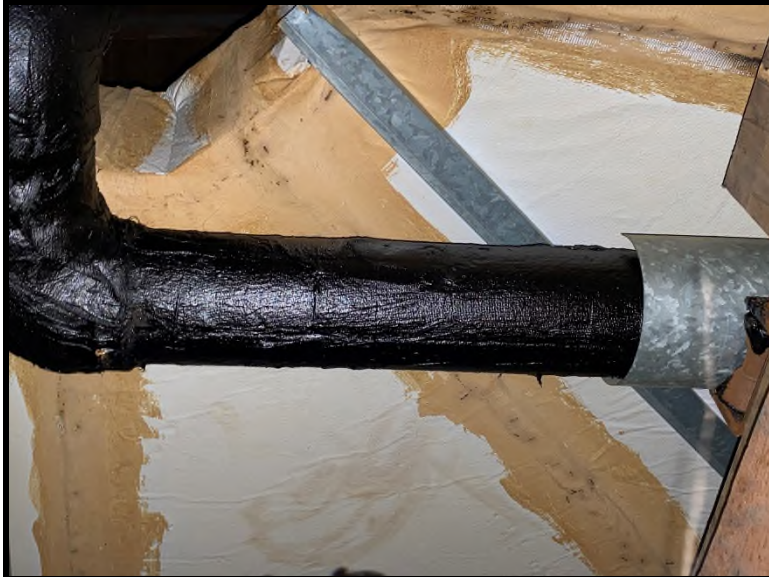
9 The black pipe mastic located in the building tested positive for asbestos (5% chrysotile).

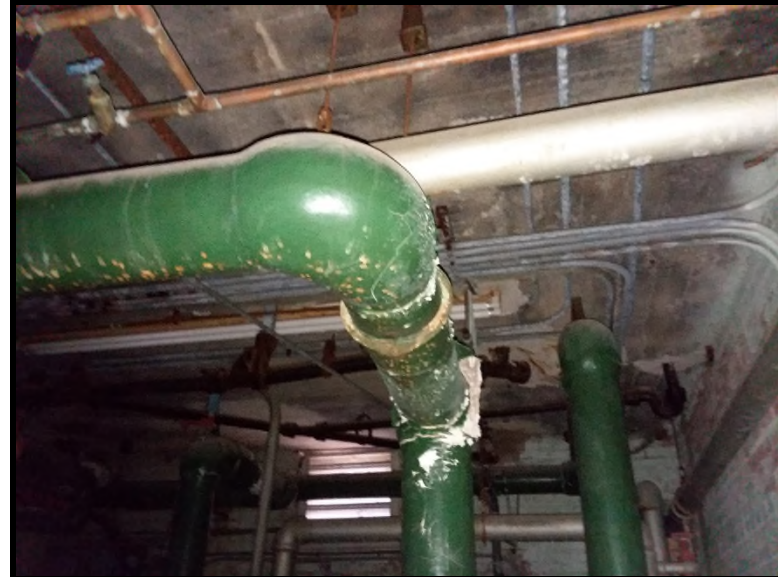
10 The hard-joint insulation over the sulfur rock insulation tested positive for asbestos (2% Chrysotile).

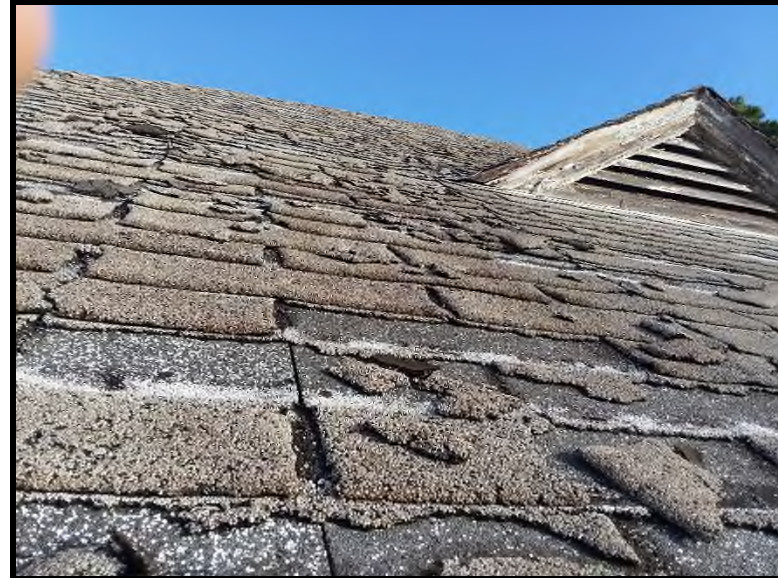
2 The asphalt shingles tested positive for asbestos (2% chrysotile).

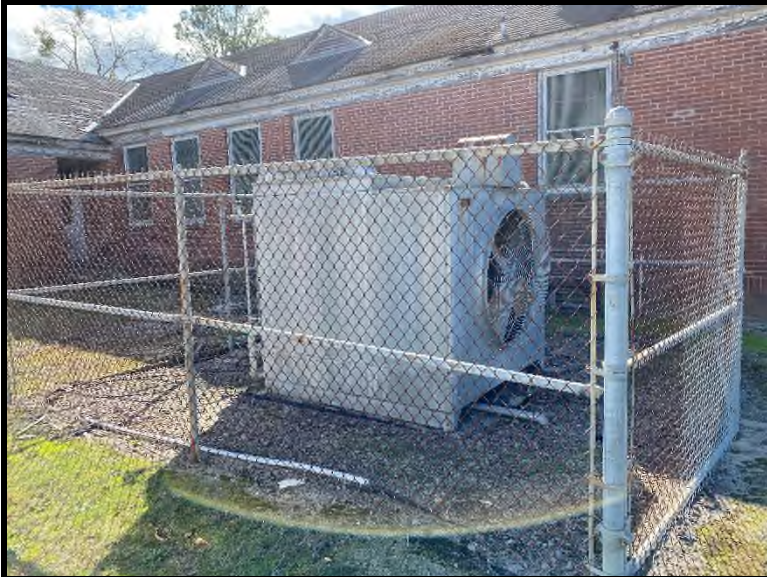
3 The silver paint located on the cooling tower tested positive for asbestos (3% chrysotile).

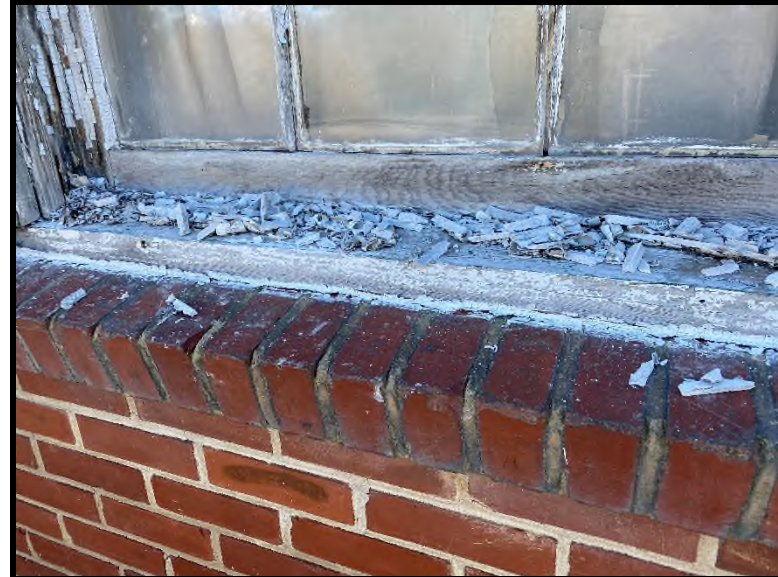
4 The exterior window glazing tested positive for asbestos (2% chrysotile).

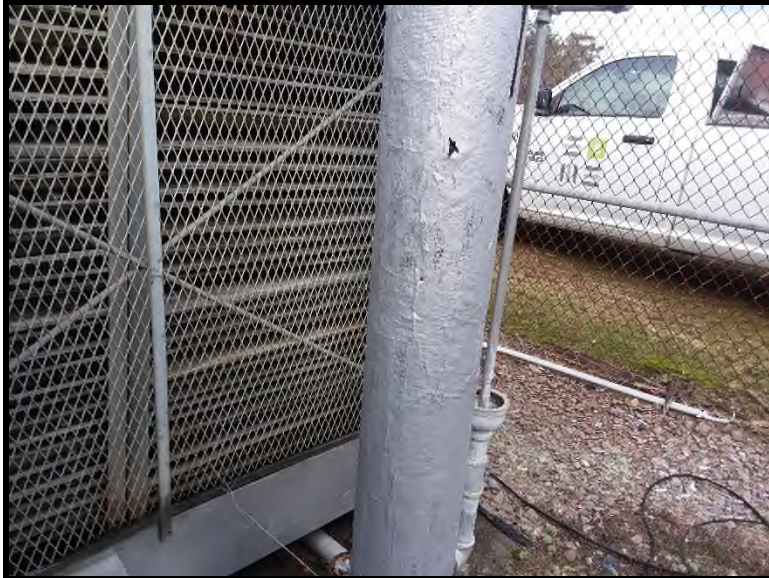
5 The pipe wrap on the sulfur rock insulation tested positive for asbestos (6% chrysotile).

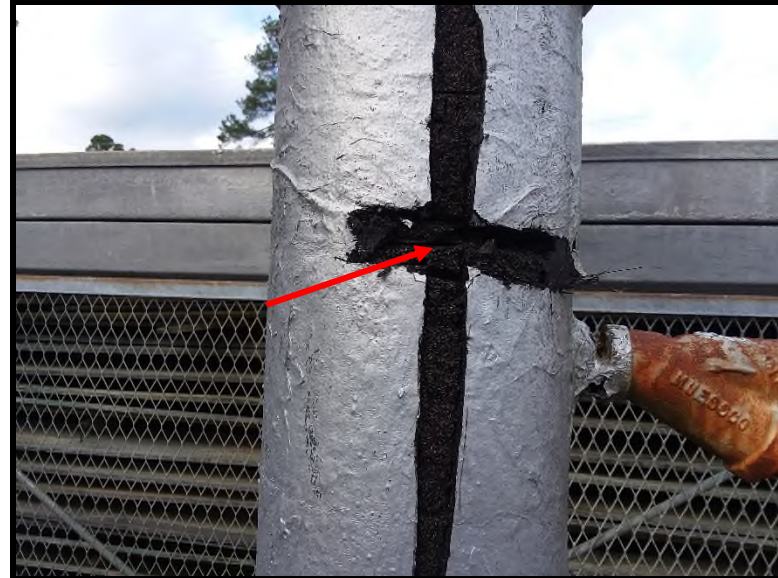
6 The black mastic located between the joints of the sulfur rock insulation tested positive for asbestos (4% chrysotile).

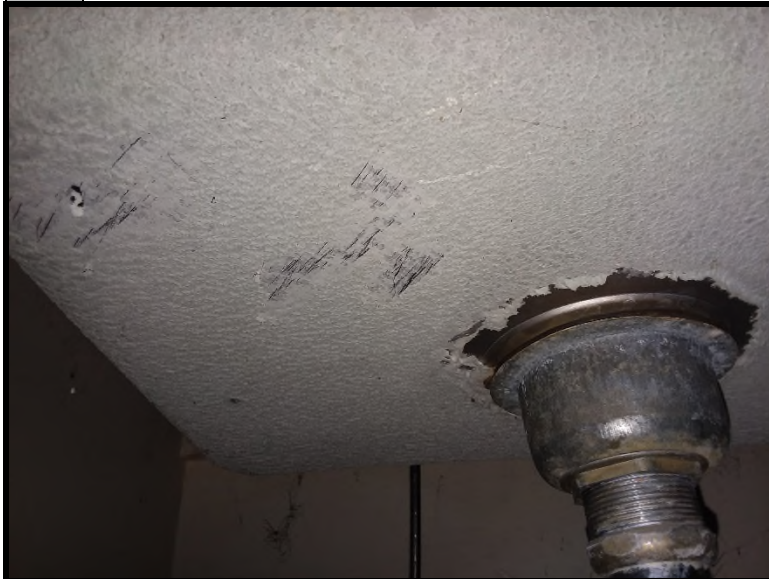
7 The gray sink coating located on the south side of the building tested positive for asbestos (4% chrysotile).

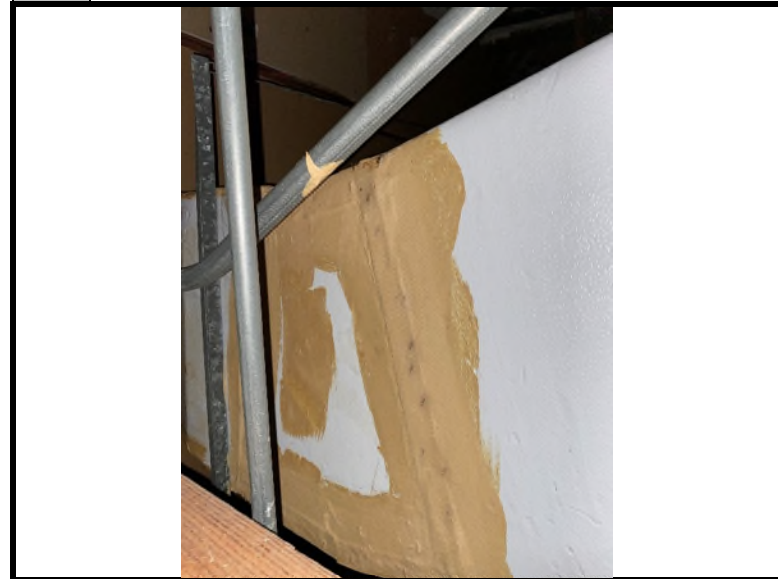
8 The yellow duct mastic located on the HVAC ducts tested positive for asbestos (5% chrysotile).

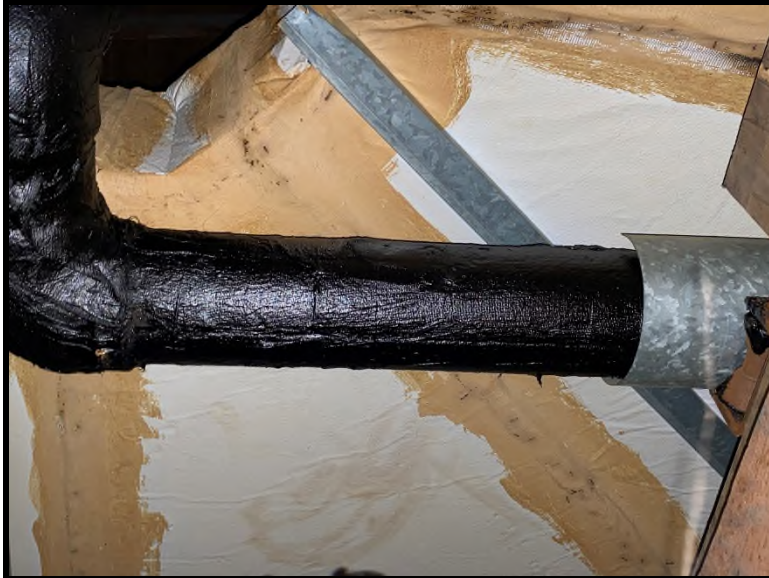
9 The black pipe mastic located in the building tested positive for asbestos (5% chrysotile).

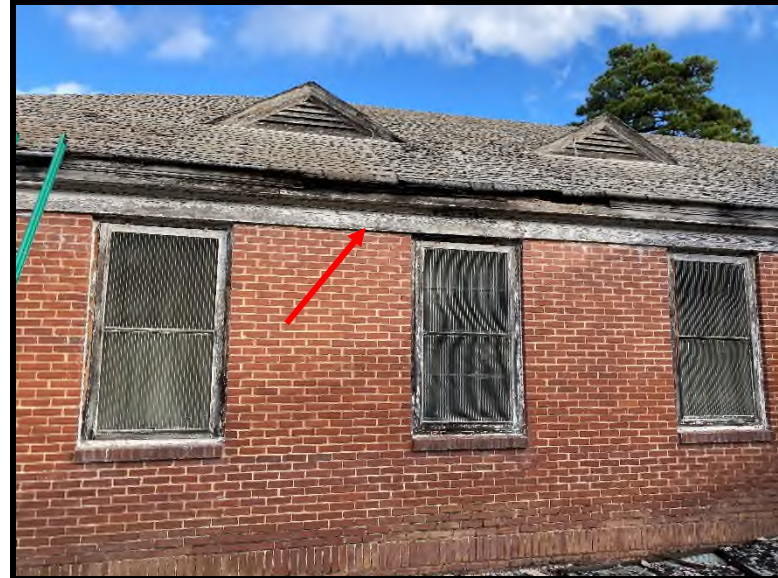
10 The white fascia board tested positive for lead-based paint (6.4 mg/cm²).

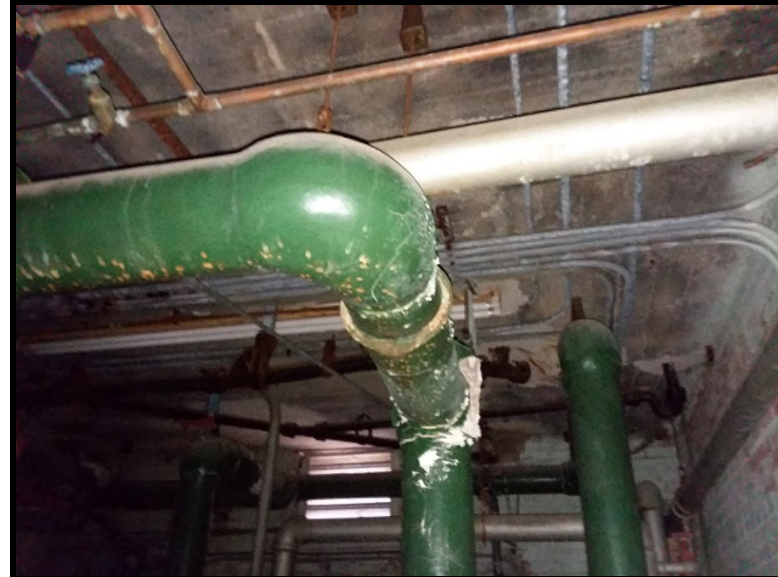
12 The hard joint insulation over the sulfur rock insulation tested positive for asbestos (2% Chrysotile).
